On January 21, 2011, Rimkus Consulting Group (Rimkus) published our Report of Findings (Report) pertaining to our evaluation of the extent of damage to the school building located at 714 East Business Highway 83 in Pharr, Texas, as a result of a partial collapse of the structure which occurred on September 22, 2010, during renovation work being performed by Texas Descon, a contractor. In that Report, we stated that demolition was supposed to be limited to the connecting structures between the main building and the detached classroom buildings at the east and west ends of the main building and was not intended to include any portions of the main or detached buildings themselves. We also stated that collapse of the east wall of the main building above the first floor and collapse of the second floor and roof from the east end of the main building westward to column line 1 were results of the demolition methods and means used by the demolition contractor to remove the connecting structure between the main building and the east detached classroom building and were outside the intended limits of demolition. We further stated that cracking in masonry columns at the north and south sides

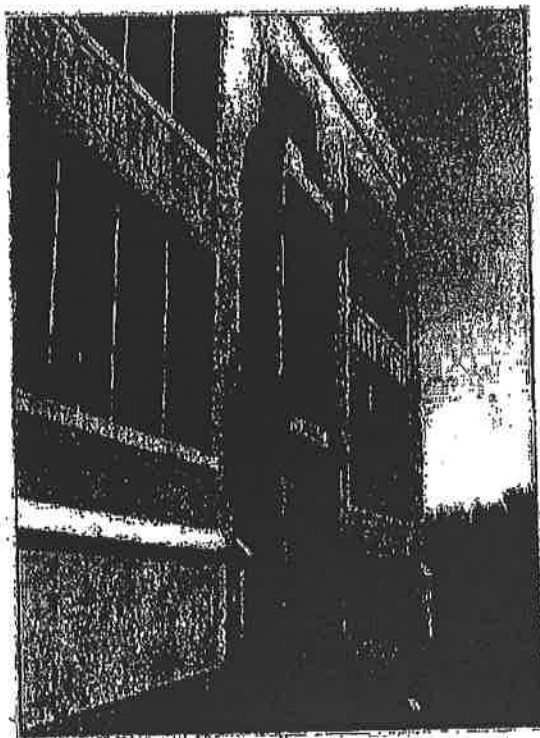
Photograph 18

- Inspection of the west end of the main building indicated the concrete columns at the sides of the west exit ended near the level of the first floor, with masonry columns extending above that level (Photograph 17). We observed cracking in the masonry columns on both sides of the exit above the first-floor level. Concrete columns had been installed at the exterior of the main building for the walkway (Photograph 18).

View of exterior columns for walkway at west end of main building, looking south.
